# A Brief Overview of Türkiye Earthquake: Evidence of Higher Peak Ground Acceleration

Rajib Biswas

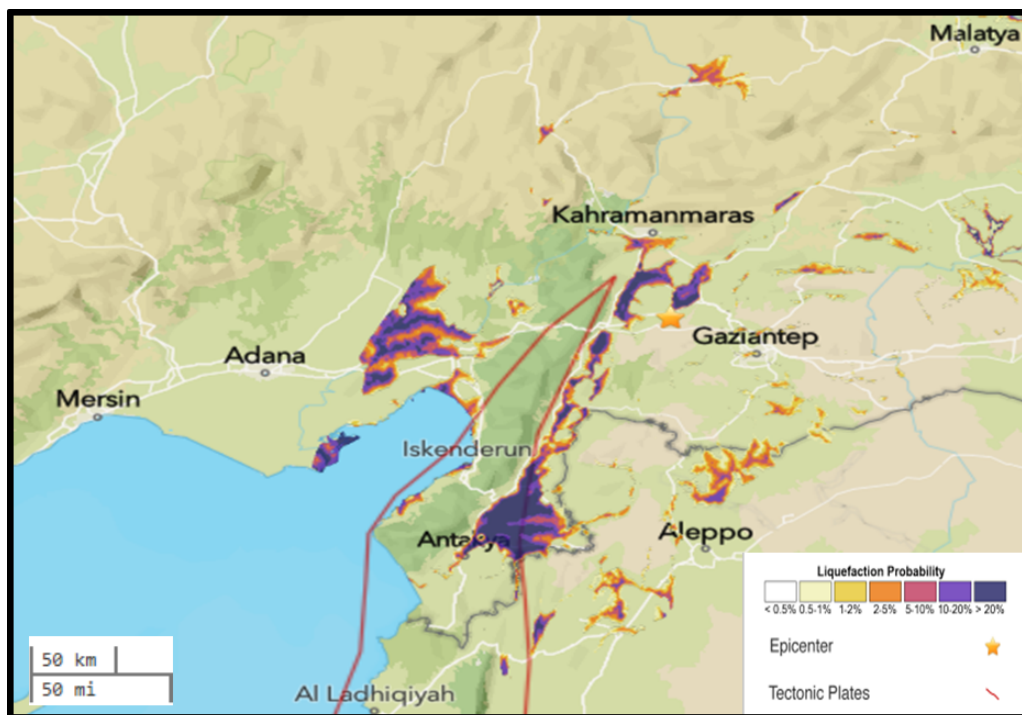
**Figure 2** depicts the level of liquefaction as observed. Unexpectedly, most liquefaction and lateral spreading sites manifested along and near coastal sites, fluvial valleys, and drained lake/swamp areas, covered by Holocene loose sediments. The distribution of mapped liquefaction sites along the fault rupture shows that most concentrations are found in Holocene sediment-filled basins [4,5].

**Figure 2.** Liquefaction map (Courtesy: USGS). The yellow star represents the main event. The red line represents the tectonic plates.

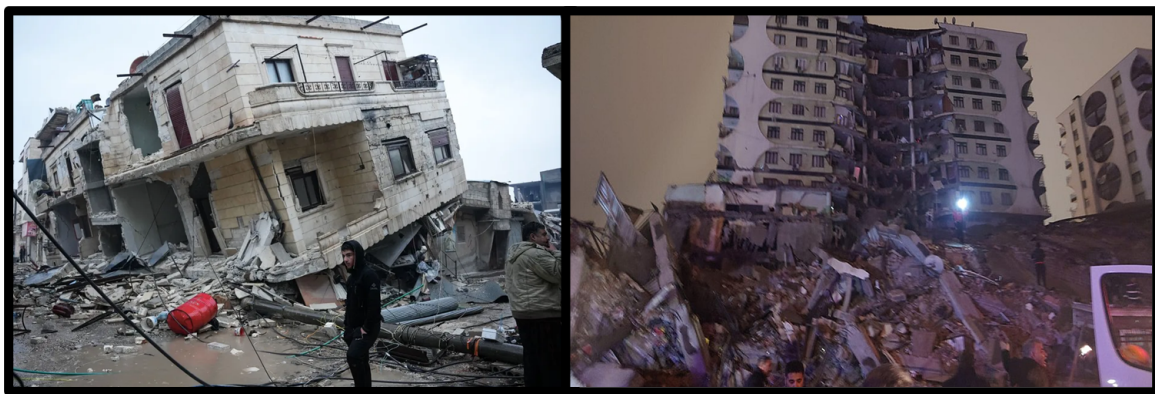
Looking at the pattern of building damages that occurred in Turkey, most of them were soft-storied buildings (Figure 3). If we look at the tectonic settings of Turkey, it is quite complex. There are three plates that collided with each other, leading to the occurrence of these huge earthquakes.

**Figure 3.** Illustration of building damage [16,17].

We know that every high-rise structure is prone to shaking. All such structures have a fundamental frequency. When seismic waves travel through a medium of low density, their velocity decreases. Therefore, it spends more time in that medium. As a result, if the predominant frequency matches with frequency of the above structure, there occurs resonance and the building sways with maximum amplitude—leading to eventual collapse. Buildings mostly

collapsed during the tragedy because of poor construction, inferior materials. Surprisingly, the earthquake caused damage to some brand-new apartment buildings that were marketed as being built to the greatest earthquake specifications, to collapse.

A key lesson from the 2023 Türkiye Earthquake is the urgent need to strengthen both the implementation and enforcement of seismic building codes. To reduce future risk, it is essential that construction practices strictly adhere to the Turkish Earthquake Code (2018) and other relevant standards. All new and renovated buildings must be subject to mandatory quality control inspections that focus on critical issues—such as proper material selection, correct reinforcement bar placement, and adequate stirrup tightening. The adoption of seismic resilience strategies—like base isolation, energy-dissipating dampers, and foundation improvements—should become standard practice for high-risk zones. Furthermore, builders and contractors must be held accountable through regular audits and severe penalties for non-compliance or code violations. These targeted measures, when rigorously enforced, will substantially improve the safety and durability of structures in earthquake-prone regions and safeguard lives during future seismic events.
