## Some Considerations on the Seismic Event of 23 November 1980 (Southern Italy)

**Keywords:** 1980 Irpinia-Basilicata earthquake; Southern Italy; reconstruction; resilience; environmental effects

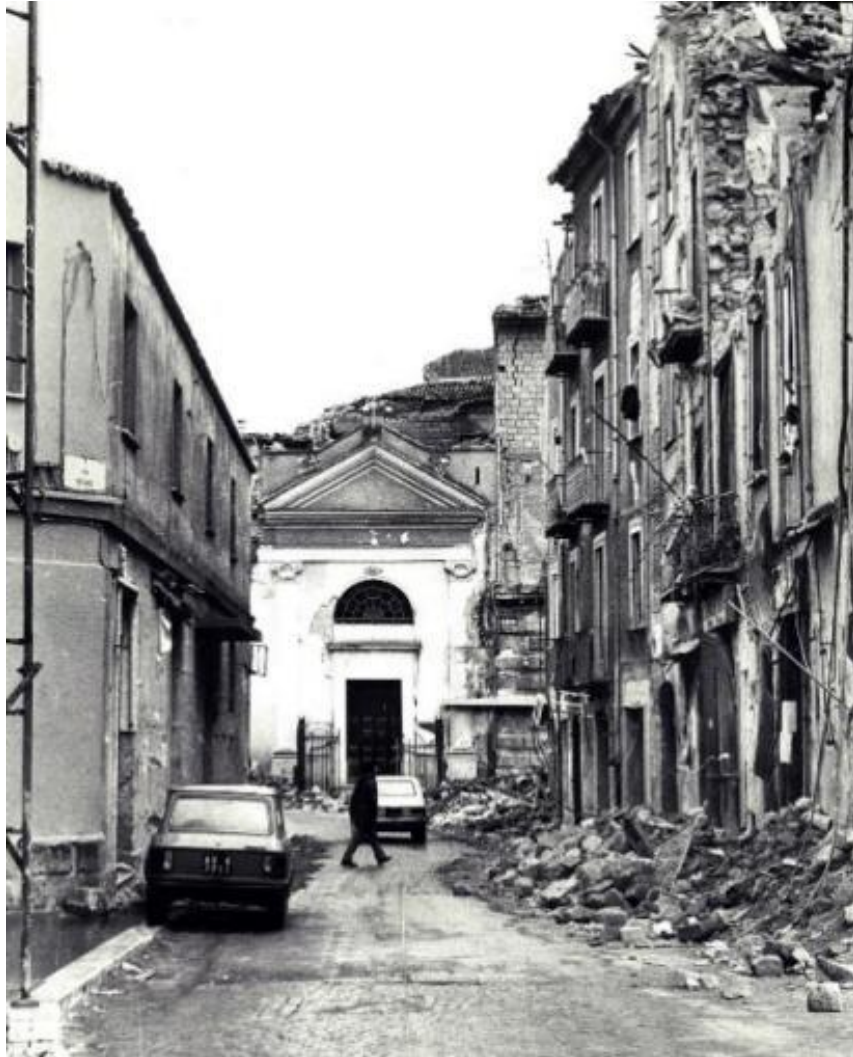
**Figure 3.** The city of Avellino just after the earthquake of 23 November 1980 (cortesy of F. Capossela).

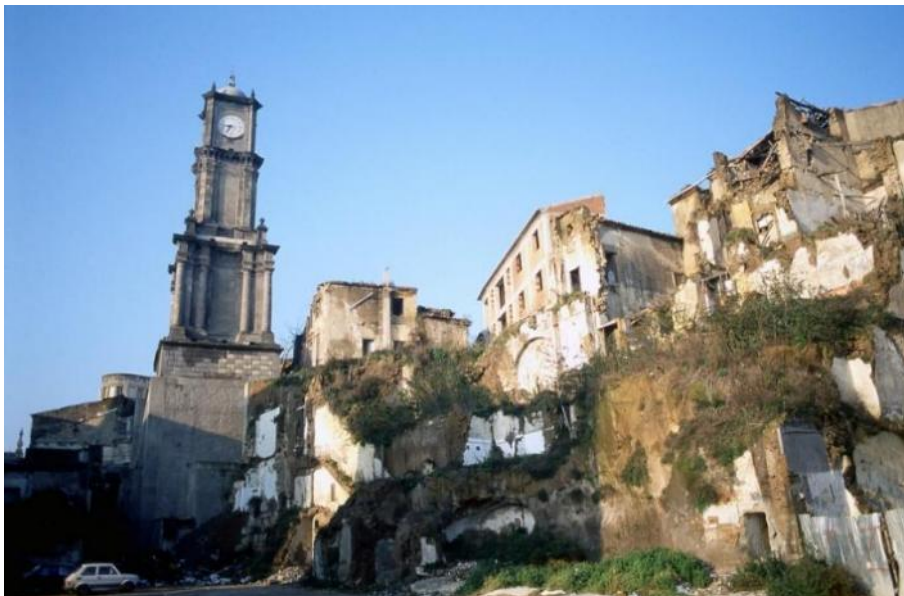
**Figure 4.** Detail of the city of Avellino under reconstruction a few years later.

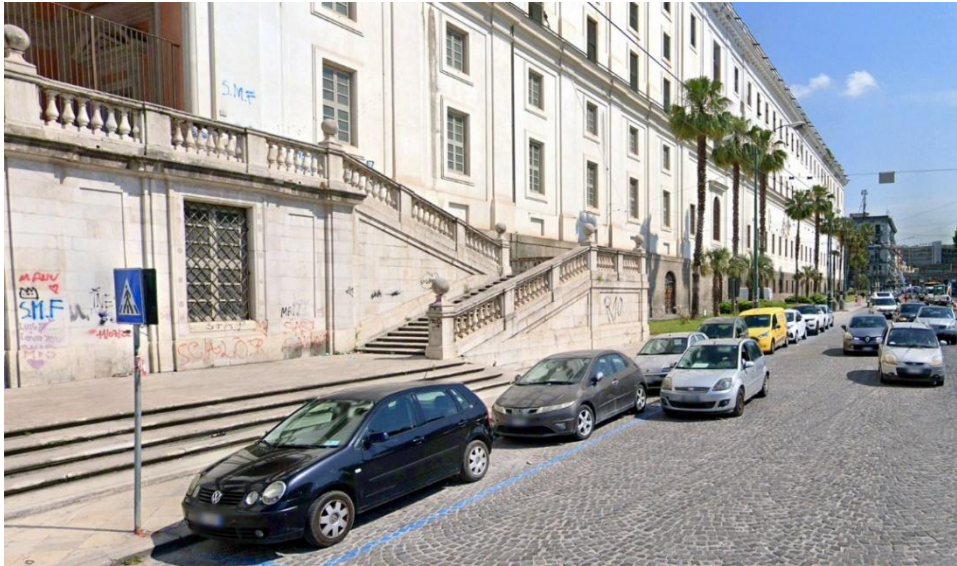
**Figure 5.** Naples: Real Albergo dei Poveri or Palazzo Fuga, current view. The building suffered severe damage in the infirmary, part of the refectory and some of the rooms on the first and second floors.

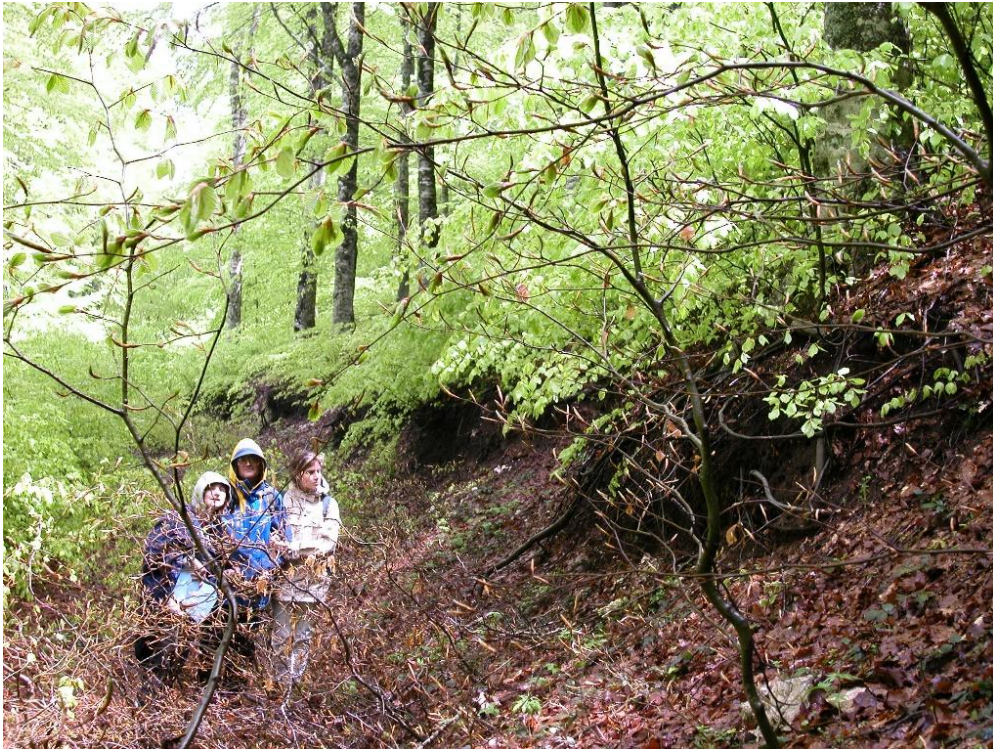
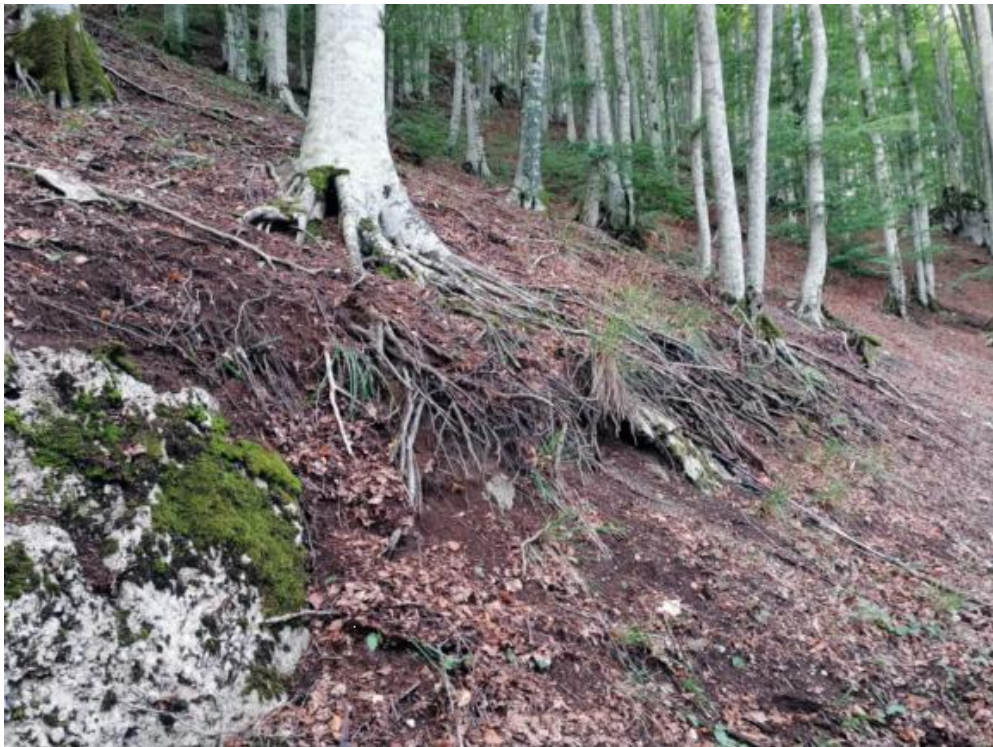
**Figure 7.** Primary and secondary effects triggered by the 1980 earthquake. (a) The original survey of primary and secondary effects triggered by the 1980 earthquake (Courtesy PFG-CNR). The top right is the trace of the surface fault segment at Piano di Pecora; (b) 1980 Piano di Pecora surface fault 24 years later; (c) 1980 Piano di Pecora surface fault 40 years later.

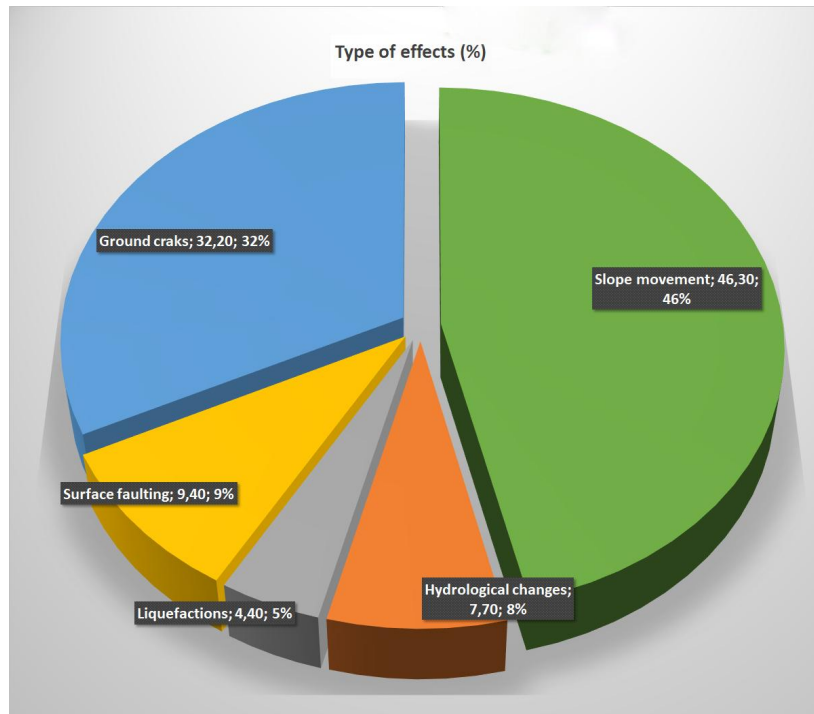
**Figure 8.** Percentage distribution of seismoinduced effects of the 1980 earthquake on the environment (Modified after [18]).

important is a complete database, published recently, with an updated dataset of environmental seismic effects, which collects 564 environmental effects: slope movements 46.3%, hydrological changes 7.7%, liquefactions 4.4%, surface faulting 9.4%, ground cracks 32.1% (Figure 8). Each environmentally triggered effect is described and catalogued by specific census forms. The majority of the effects are located in the epicentral area: 56.9% of the total effects classified were located within 20 km of the macroseismic epicentre, and 84.4% within 40 km. However, some effects were located nearly 200 km from the epicentre [18].

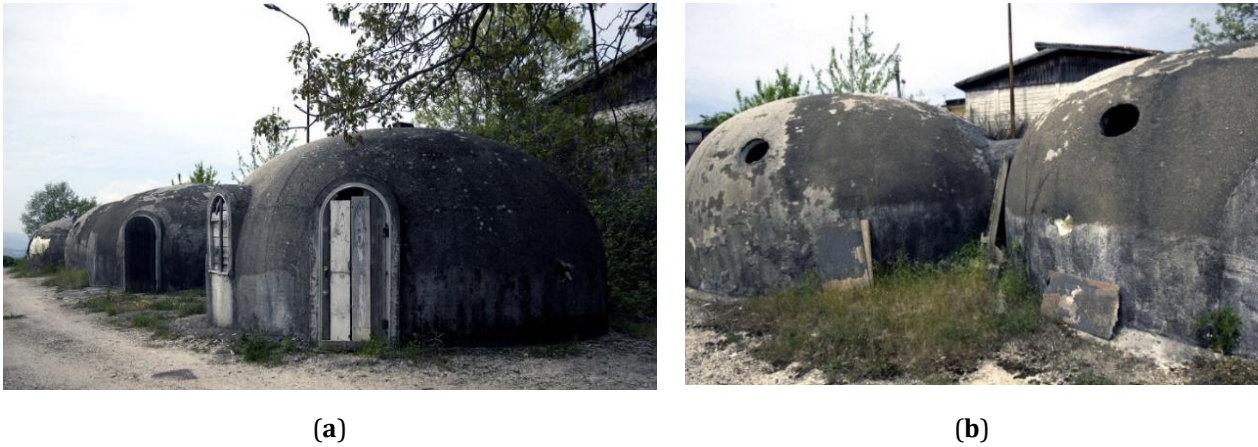
**Figure 9.** San Potito Ultra (Avellino province) temporary housing consisting of thermo-igloos, which were dismantled only a few years ago (Photo by Sabina Porfido, [47]). (a) Examples of temporary accommodations; (b) Detail of the thermo-igloo of San Potito Ultra (Avellino).

through time, in others they persist today although mostly in a state of decay, or in the best case, still partially used as in Conza della Campania or with touristic functions, as happened before the Covid-19 pandemic in San Mango sul Calore (Figures 10 and 11), and Romagnano al Monte [48–50].

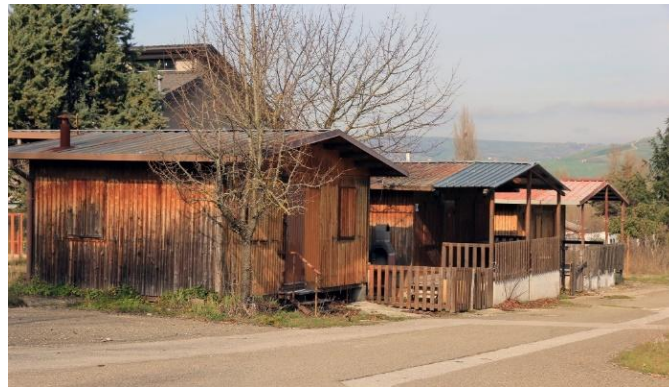
**Figure 10.** Conza della Campania (Avellino province). Temporary housing consisting of prefabricated wooden houses are still visible today ([48,49]).

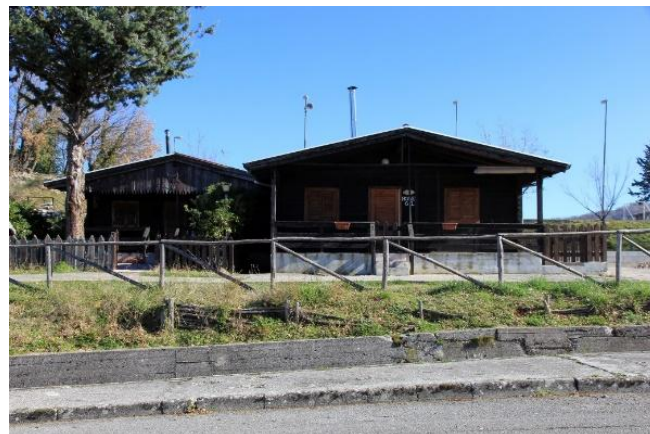
**Figure 11.** San Mango sul Calore (Avellino province). Complex prefabricated wooden housing used for post-earthquake, successively used for tourism functions, and after the Covid-19 pandemic completely abandoned[48,49].

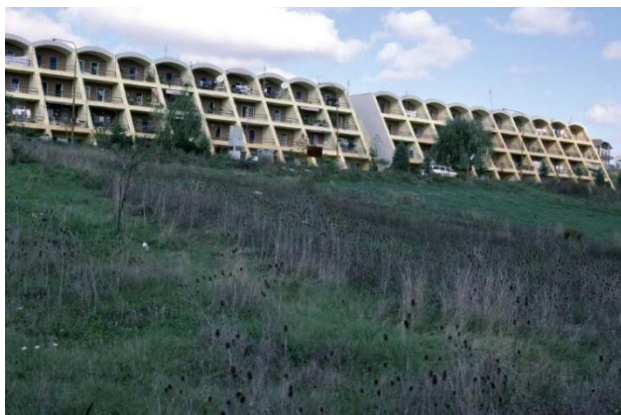
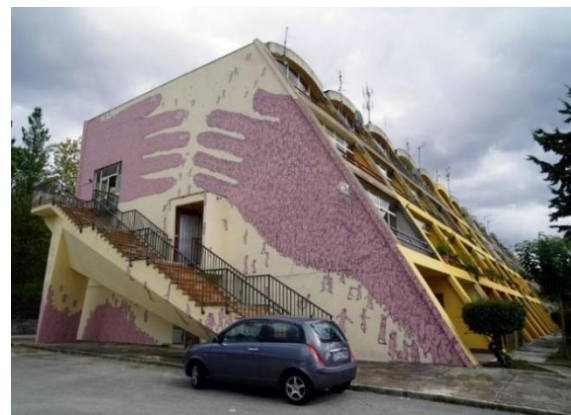
**Figure 12.** Lioni (Avellino province) “*Campo Bergamo-Bergamo Camp*”. (a) Concrete apartment block built with funds raised by citizens of Bergamo and province, donated to the people of Lioni after the 1980 earthquake; (b) the mural in the same condominium depicting in 2020 the solidarity of the people of Lioni to Bergamo, epicenter of the Covid-19 pandemic [48,49].

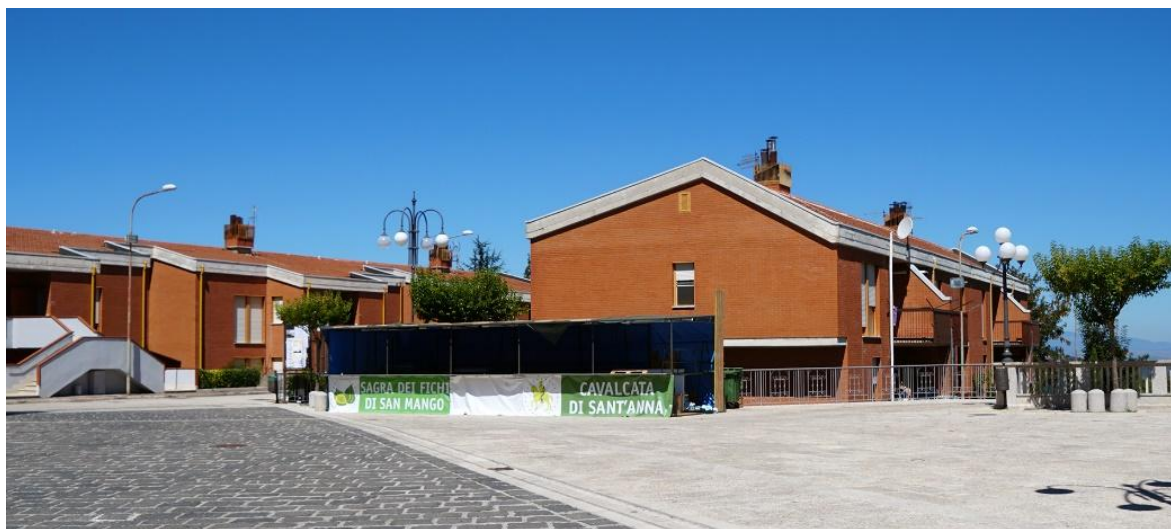
**Figure 13.** San Mango sul Calore (Avellino province) “*Italian-Canadian village*”, example of housing built thanks to the international solidarity of Italians abroad [48,49].

During the dramatic emergency phase, a massive intervention of volunteers from all over Italy took place, directly involved in the field with development of great national and international solidarity, and a generous collection of funds for the reconstruction. An example among all is the “Campo Bergamo-Bergamo Camp” in Lioni (Figure 12a,b), a town strongly hit by the earthquake with loss of 228 people. The city of Bergamo located in Northern Italy, immediately twinned with the destroyed Irpinia town of Lioni ( $I = X$  MCS), firstly has built a village of prefabricated houses and then, very rapidly, built a futuristic condominium of three reinforced concrete buildings delivered to 60 families in 1985 and still inhabited. On the fortieth anniversary of the earthquake (1980–2020), one side of the building was enriched with an artistic mural, which shows two outstretched hands approaching each other and aims to symbolically represent once again the solidarity, closeness and brotherhood of the two communities. Reciprocally, from Lioni towards Bergamo, the epicenter of the dramatic Covid-19 pandemic which caused an impressive number of deaths, a chain of solidarity took place [45,48,49] (Figure 12b [51]). Examples of international solidarity are also found in the current toponymy of some countries, which highlight the interventions carried out for reconstruction, such as the Italian-Canadian village in San Mango sul Calore (Figure 13) or the Swiss village in Teora [45,48,49].

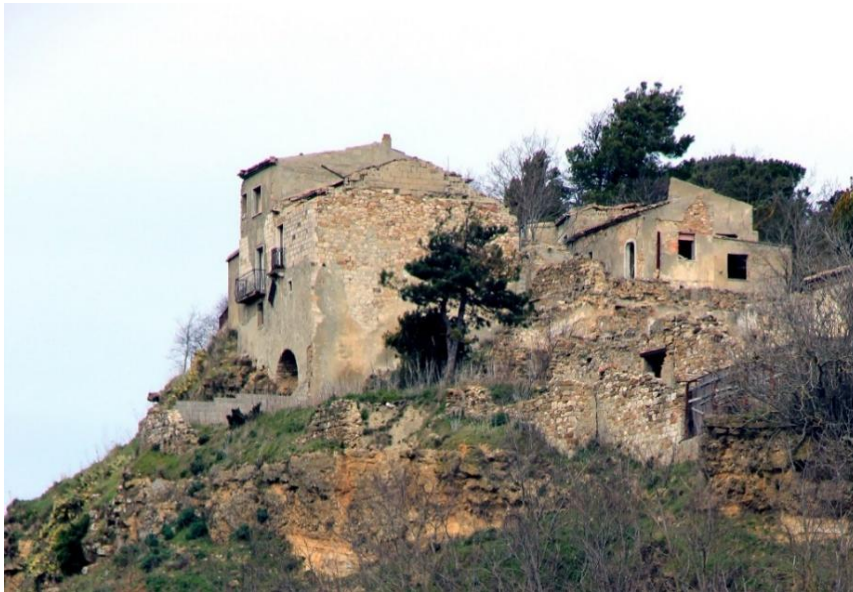
**Figure 15.** Conza della Campania (Avellino province). Examples of very poor constructions consisting of rubble stone with little mortar were very common at the time of the 1980 earthquake throughout the historic centers of the Campano-Lucano Apennines (Photo by Porfido & Spiga 2021).

First of all, it must be said that the historic centers of all the Apenninic villages affected by the earthquake were mostly made up of extremely poor buildings: houses leaning against each other, in natural stone, sometimes in gray or yellow tuff, or in bricks bonded with poor quality and/or little cement mortar, construction

typologies characterized by mostly superficial, or even missing, foundations, thrusting roofs with wooden beams, without horizontal curbs, of which some striking examples were San Mango sul Calore, San Michele di Serino, Laviano, Balvano, Castelnuovo di Conza, Conza della Campania (Figure 15), Calabritto, etc.

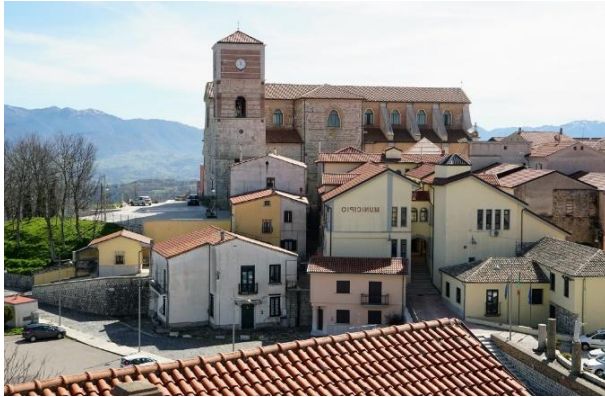
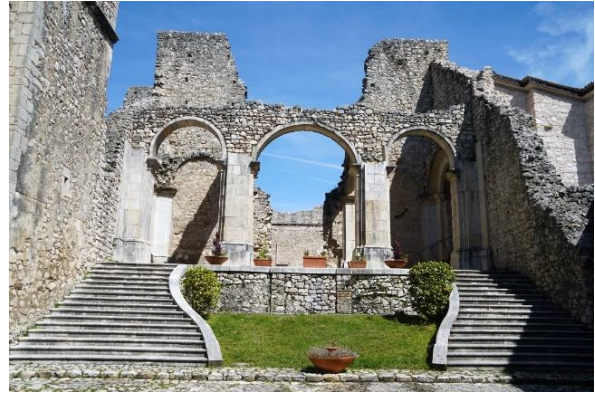
**Figure 16.** Sant'Angelo dei Lombardi (Avellino province): reconstruction of a severely damaged village by trying to recover pre-existing building types. Right, the Goletto Abbey, recovered and restored [48,49]. (a) Examples of reconstructions in historic centres; (b) Restoration work at Goletto Abbey.

The newly inhabited centers were almost generally rebuilt *in situ* with prevalent building typologies in reinforced concrete; only in a few cases it was possible to recover the pre-existing buildings [40–42,57] through long interventions of recovery, first conservation, and then restoration: some examples are the historic center of Sant’Angelo dei Lombardi (Figure 16a,b), in which the community’s attachment to the original town prevailed and therefore the desire to rebuild in any case “*as it was, where it was*”, as also demonstrated by the recovery of the Goleto Abbey (Figure 16b); moreover, also in the town of Quaglietta, a hamlet of Calabritto, the ancient medieval village was completely recovered and enhanced, in order to finally be used in 2016 as “*Albergo Diffuso-diffuse hotel*” for tourism purposes.

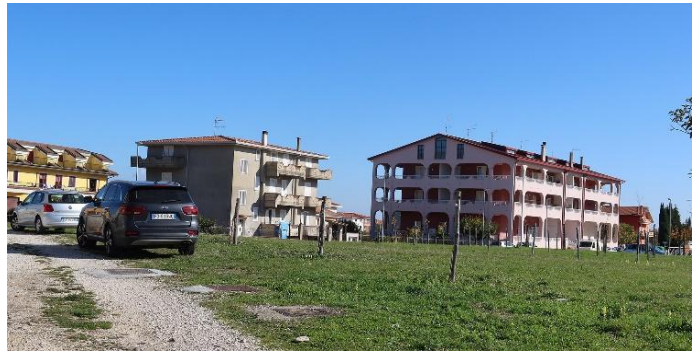
**Figure 17.** Calitri (Avellino province). (a) Reconstruction of the historic center with the preservation of the original urban heritage [48,49]; (b) Building expansion zone.

The new urban centers, after reconstruction, are today generally characterized by wider road systems, the narrow streets with the characteristic alleys are preserved and appropriately valorised only in some cases, such as Guardia dei Lombardi or Calitri, where part of the historic center is recovered, although it had been affected by a landslide of considerable size [54] maintaining however the appearance of the pre-earthquake town, at least in its original nucleus while the expansion zone is rather chaotic, without a real architectural structure (Figure 17a,b).

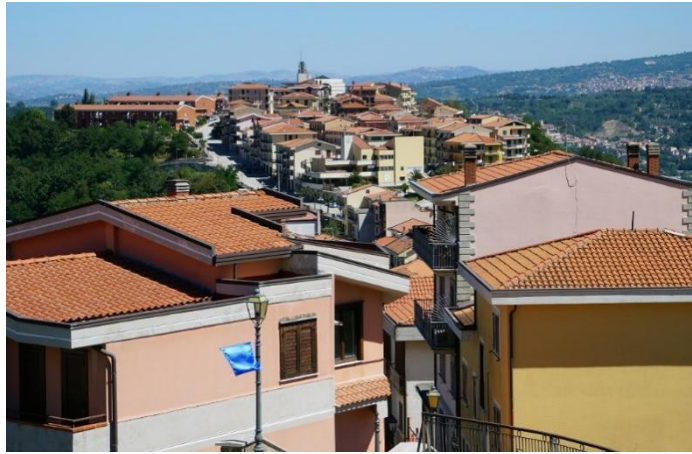
**Figure 18.** San Mango sul Calore (Avellino). Overview of the village completely rebuilt after a substantial foundation soil remediation. (Photo by Porfido & Spiga, 2020 [48,49]).

Rebuilding *in situ*, despite everything, even after a huge tragedy, is the case of the municipality of San Mango sul Calore, almost totally destroyed by the earthquake (I = IX MCS and VIII ESI-07) with 84 fatalities. The seismic microzonation investigations of the PFG highlighted that the causes of the destruction of the town were due both to the poor quality of the houses and to the unfavorable position of the ridge, together with the hydrogeological structure of the territory, characterized by widespread phenomena of more or less accentuated instability along the slopes [54,59–61]. San Mango sul Calore was rebuilt from scratch *ex-novo* on the original site after important soil consolidation works on the hill on which it was built, effectively modifying its original profile, lowering and leveling the top, but maintaining the overall structure of the destroyed town (Figure 18).

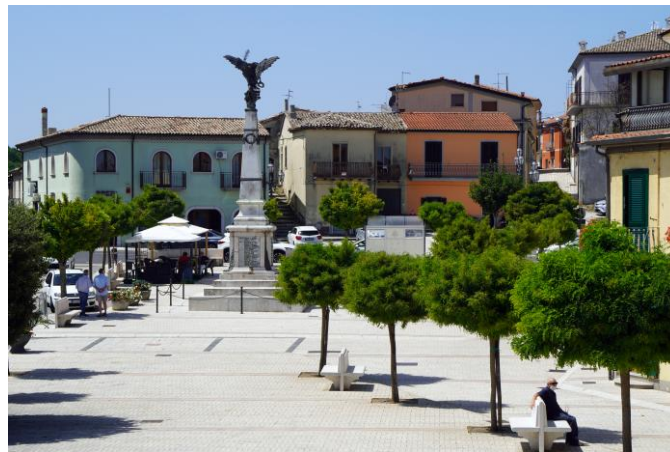
**Figure 19.** Guardia dei Lombardi (Avellino province). Reconstruction of the village keeping in mind the old architectural plan [48,49].

In other cases, the old and new construction typologies try to coexist, managing to blend perfectly as in the case of Guardia dei Lombardi, Torella dei Lombardi or Caposele (Figures 19 and 20).

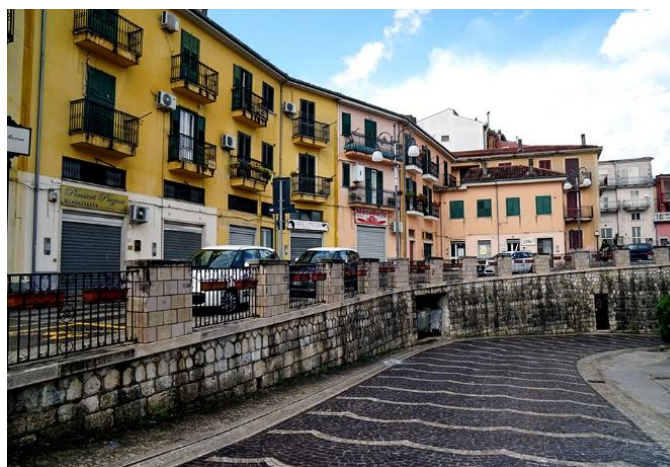
**Figure 20.** Caposele (Avellino province) New construction integration into the old structure of the village [48,49].

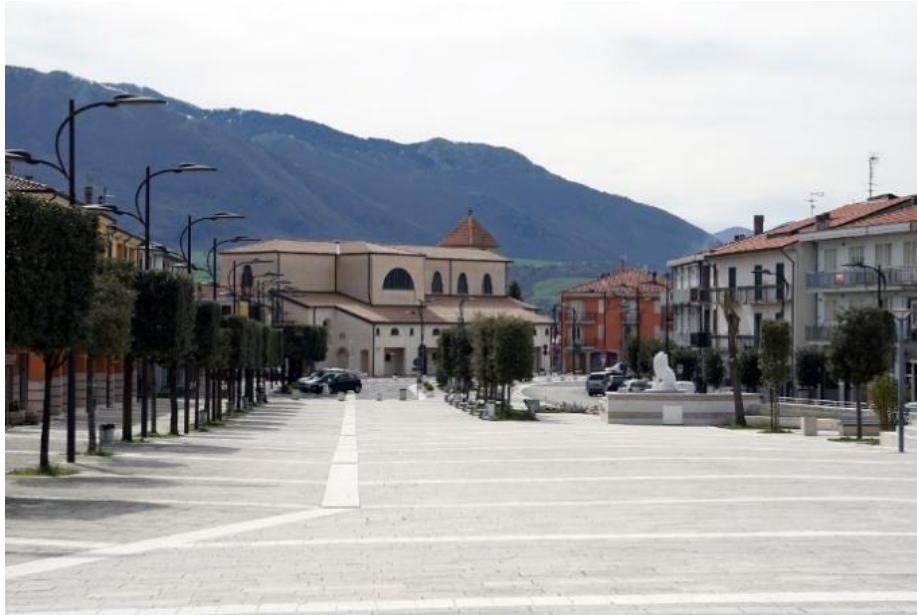
**Figure 21.** Lioni (Avellino province). The new historic centre, reconstructions with innovative architectural interventions [48,49].

In other municipalities, such as Lioni, Teora, Balvano, the choices to modernize and make buildings functional, especially public ones, prevail, thanks to the innovative intervention of some architects (Figures 21–23) [48,49]; in other cases, such as Laviano, Calabritto and Santomena (Figures 23–26) although modern construction in reinforced concrete prevails, towns without a real identity can be found, with public and private buildings lacking real connection with the original landscape, sometimes representing an isolated nucleus, perennial testimony of the moment of tragedy, as in the case of Romagnano al Monte or Senerchia, as regards the upper part of the town.

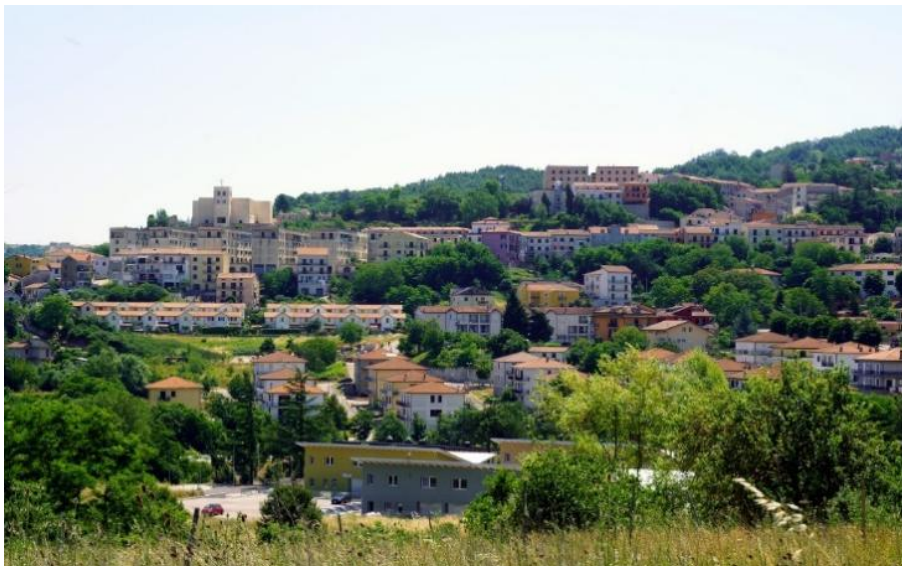
**Figure 22.** Teora (Avellino province) Rebuild the village according to construction criteria that favor the use of reinforced concrete (Photo by Porfido & Spiga 2022).

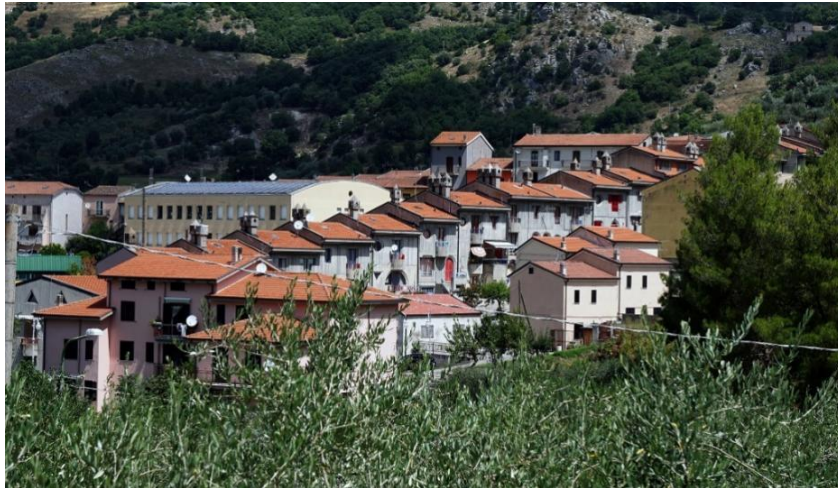
**Figure 23.** Balvano (Potenza province)—The village was completely rebuilt mostly in reinforced concrete with architectural structures designed by artists Boffo and Eibl [48,49].

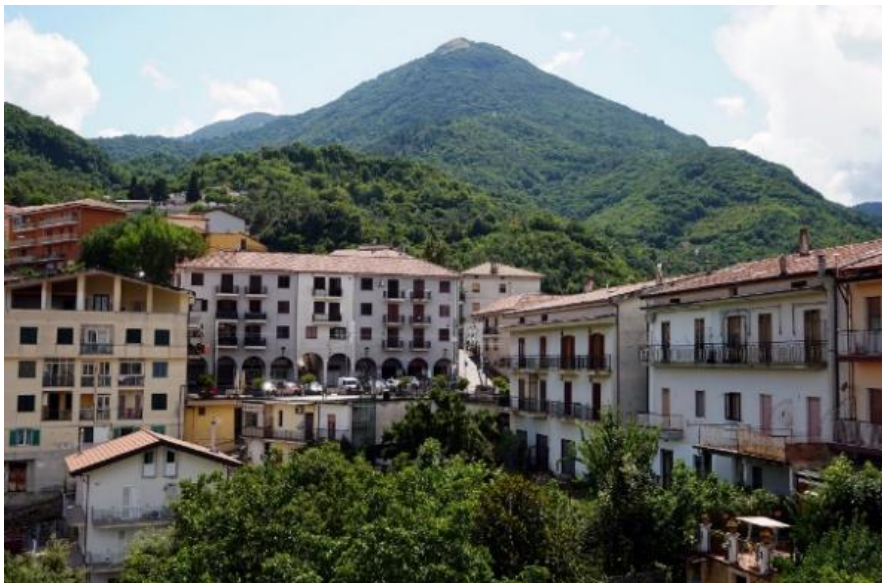
**Figure 25.** Calabritto (Avellino province) Reinforced concrete buildings without a well-defined architectural identity to reproduce the historic village prevail ([48,49]).

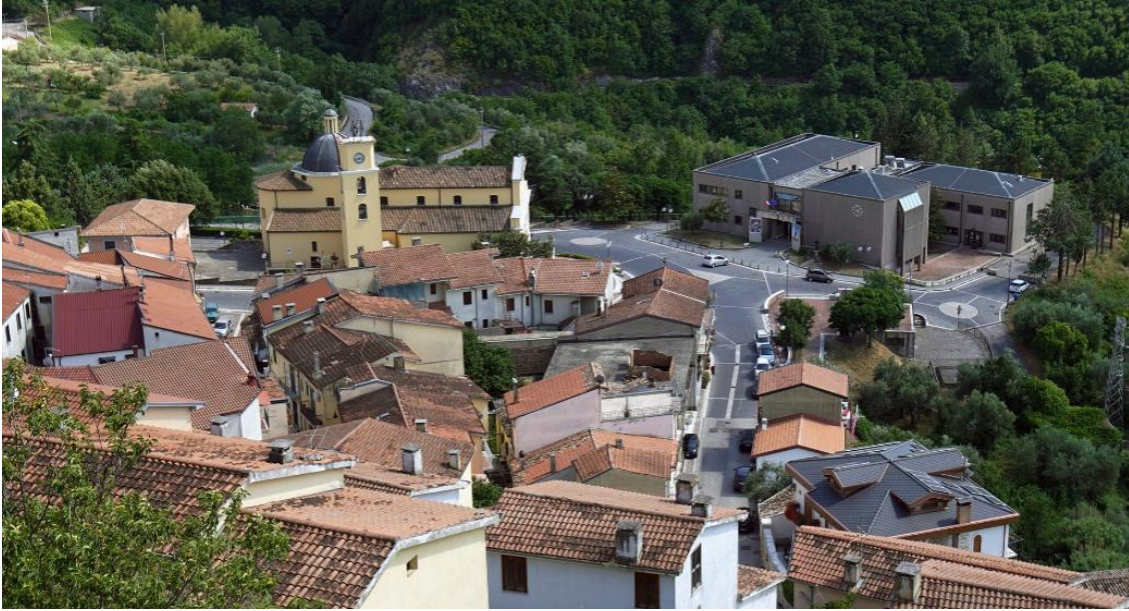
**Figure 26.** Santomenna (Salerno province)—View of part of the historical center completely reconstructed in reinforced concrete, the large gray building, top right, in the photo is the town hall (Photo by Porfido & Spiga 2022).

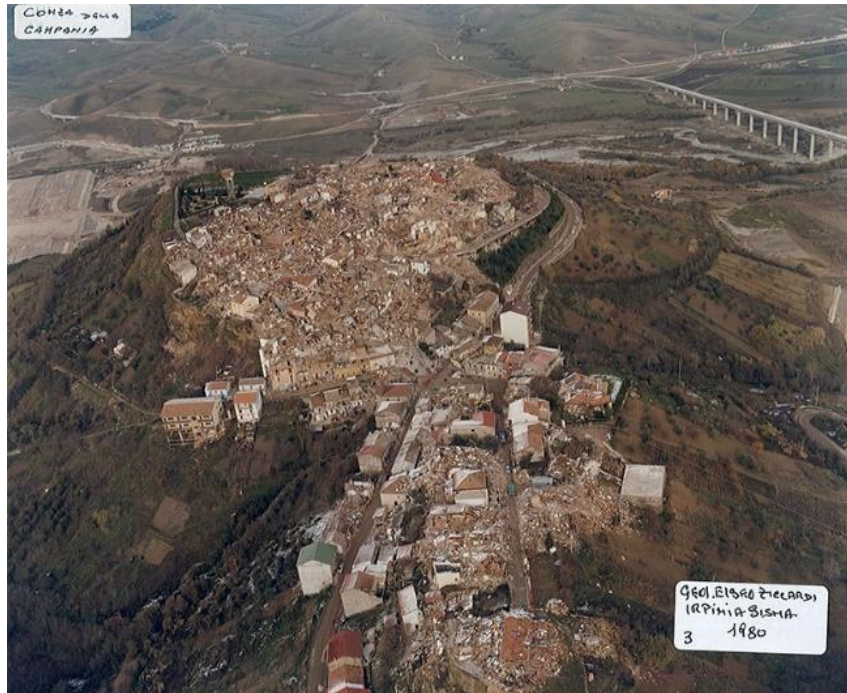
**Figure 27.** Conza della Campania (Avellino province) Aerial photo taken immediately after the 1980 earthquake in which you can see the destruction of the village (Courtesy of Dr. E. Ziccardi).

The small town of Conza della Campania (Avellino province), at a distance of a few kilometers from the macroseismic epicentre, suffered enormous damage assessable as I = X MCS [1] and VIII ESI-07 [5]. About 90% of the buildings collapsed and the remaining were seriously damaged, with 186 deaths (Figure 27).

The damages were conditioned by the poor construction quality, mostly houses without foundations, leaning against each other, and by the peculiar morphological conditions on which the town was built: two hills made up of alternations of extremely heterogeneous and poor soil made up of clay and sandy clays in the lower part, conglomerates with sand and sandstone in the central part, and conglomerates of medium-low resistance in the upper part, as highlighted by Guelfi in the report of the preliminary microzonation survey carried out for the PFG-CNR project [54,61,62].

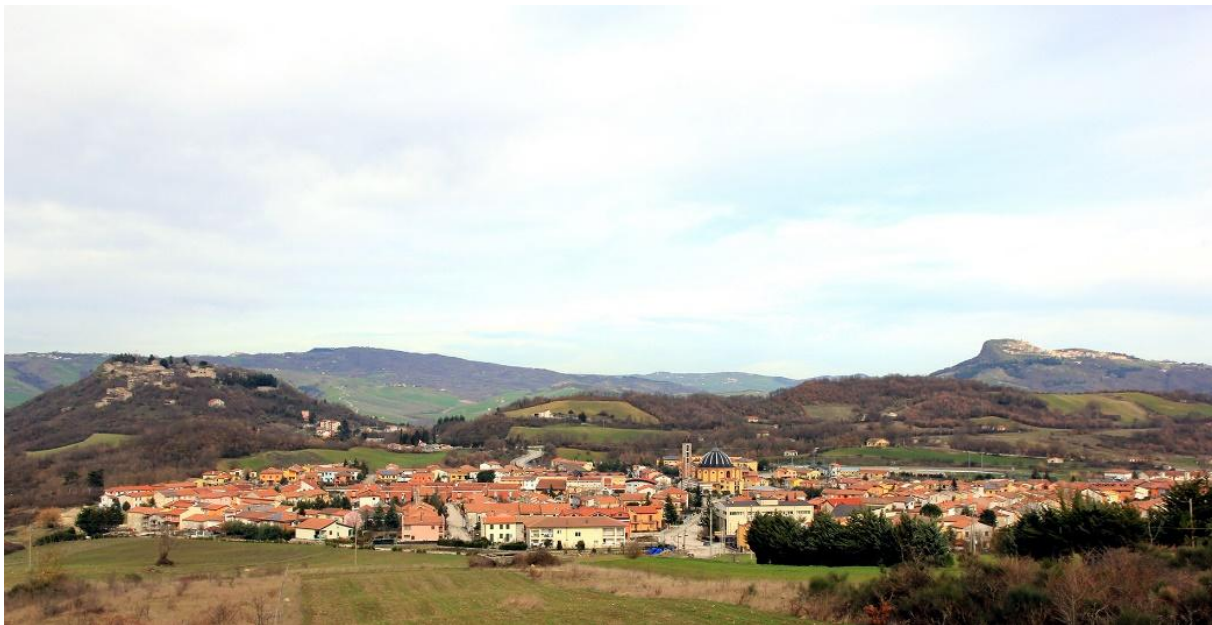
**Figure 29.** New Conza (Avellino province) panoramic view of the new town as it appears today. In the background on the right at the top of the hill the characteristic village of Cairano, and on the left the remains of old Conza (Photo by Porfido & Spiga, 2022).

In Conza, the 1980 earthquake also produced various effects on the environment such as modest-sized landslides, cracks and settlement of the ground. The problems connected to the possible geological effects of local amplification, identified by the technicians in charge of the subsequent seismic microzonations [6,53,60], together with the memory of the victims linked not only to the 1980 event but also to the old memory of the dramatic destruction suffered by the town after the historical earthquakes occurred in 1466, 1517, 1694, 1732 and 1930, led the community to choose a different site to rebuild the town. Two villages of Conza currently coexist: the village of the recent past with its ruins, recovered and enhanced through the creation of an archaeological park which also preserves the remains of the ancient Roman and pre-Roman “*Compsa*”, discovered just after the event of 1980 [26,40] and the new Conza, built in Piano delle Briglie, 4 km far from the original nucleus where the flat topography guarantees, according to the designers, safer conditions. The town of Conza Nuova, designed by Professor C. Beguinot of the University of Naples and completed with the variations carried out by Professor V. Bordini of the University of Rome with F. Dinelli (Figure 28), is a town with a modern layout characterized by earthquake-proof low-rise houses and wide streets with a central nucleus containing the cathedral. It is useful to underline that the new town, according to Beguinot’s architectural design, had to be connected to the old town with a series of connecting structures, in fact never built due to abandonment, the subsequent depopulation due to the emigration of residents for the lack of economic development of the area. Currently, the town is also a destination for environmental tourism linked to the naturalistic oasis of Conza, thanks to the presence of the artificial lake of the dam on the Ofanto River (Site of Community Importance SIC IT8040007)(Figure 29).

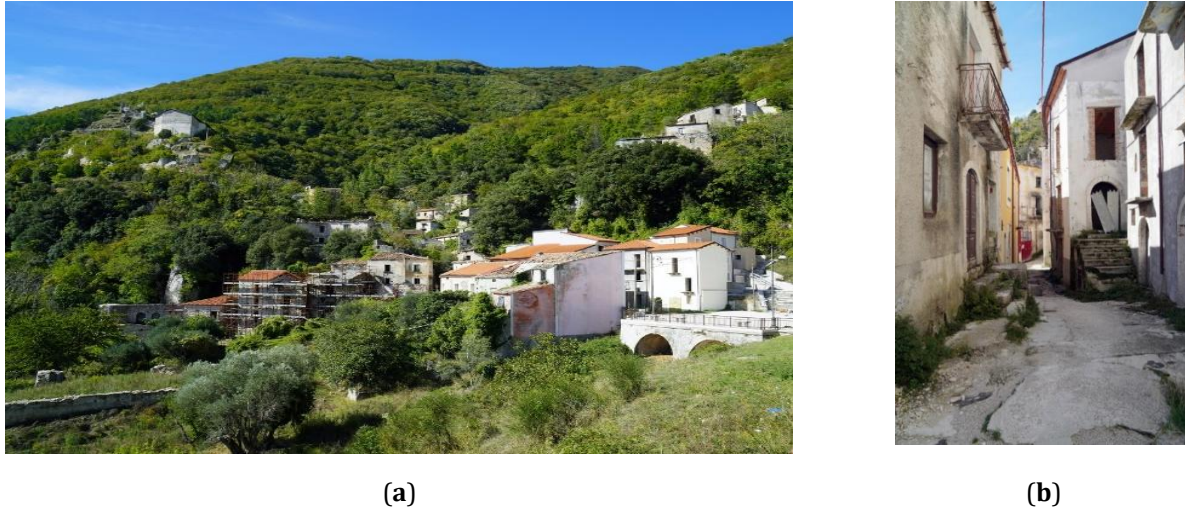
**Figure 30.** Senerchia. (Avellino province) Remains of the original structure of the old village of Senerchia, which is currently being recovered, the new village was rebuilt not far away [48,49]. (a) The old village dwellings; (b) Detail of the old town.

In the mountain range of Campania Apennines there is no town better than Romagnano al Monte (province of Salerno) and perhaps a few others, for example, Senerchia (Figure 30a,b), can transfer into today's reality the exact image of the urban cultural heritage of the inland towns before the 1980 earthquake [46,63].

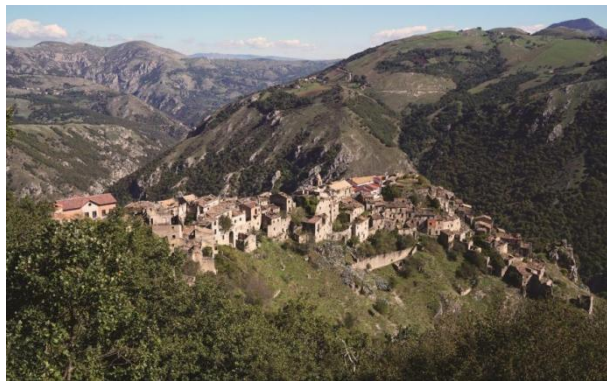
**Figure 31.** Romagnano al Monte (Salerno Province)—Panoramic view of the old village frozen at the time of the 1980 earthquake. The village was completely abandoned and rebuilt a few kilometres away, in a geologically less hazardous location [48,49].

In fact, this earthquake was the one that most left its mark on urban planning, following which, however, the town has not undergone any significant changes. Even for Romagnano al Monte, a small village in the province of Salerno with only 370 inhabitants, located at 650 m above sea level, on a spectacular limestone ridge, a few steps from the gorges of the Platano River and a few kilometers from the epicentral area, a political decision prevailed of moving to another area. The main reason was linked to the overall level of damage to the town characterized by the collapse of the churches, the serious damage to the town hall and above all by declared unusability of 446 housing units [7], reaching the I = VIII-IX MCS degree. The particular geomorphological and geological structure also contributed to the choice of relocation, in fact the position on the crest made worse the effects of the seismic shaking. Furthermore, along the slopes of the ridge, numerous rock fall phenomena were also frequent due to the high degree of fracturing of the rocky substrate. The little town was evacuated and abandoned, effectively becoming a “ghost town” [46,63,64], not without controversy due to the lack of recovery despite the large funding received, becoming a town that sometimes opens to tourists for some sporadic summer events (Figure 31).

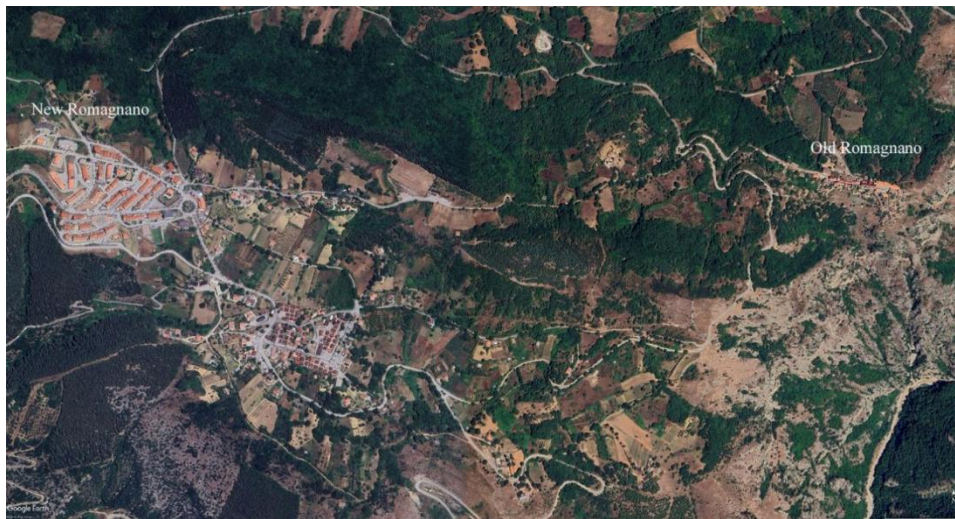
**Figure 33.** New and old Romagnano al Monte (Salerno province)—On the left is the new village of Romagnano, while on the right is the old small town located on a steep ridge (Image from Google, April 2024).

The new town was rebuilt in the locality called Ariola, 2 km away from the historic centre, in a less spectacular position, but certainly with easier access for inhabitants and tourists. The new urban structure, also in this case, is mainly made up of anti-seismic houses, in reinforced concrete, without, however, a particular identifying design in the overall architectural system (Figures 31–33).

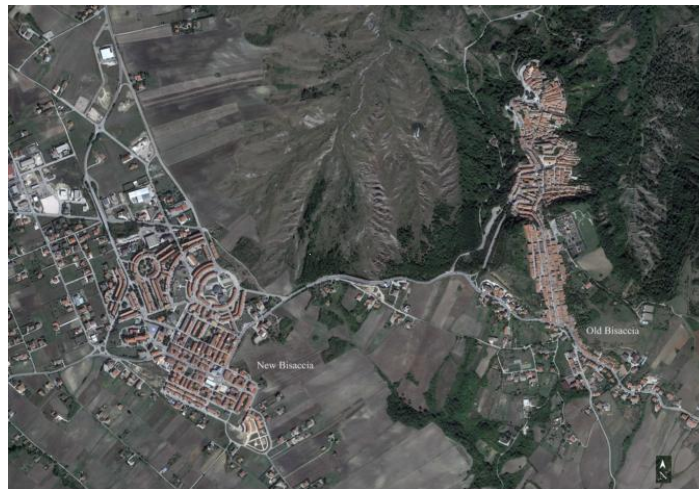
**Figure 34.** New and old Bisaccia (Avellino Province): on the left, the new town centre of Bisaccia, with its regular architectural structure, designed by architect Aldo Loris Rossi, while on the right is visible the old town centre with an elongated layout towards the N to retrace the basic morphology on which it rests (Image from Google, April 2024).

The municipal administrations therefore opted for the reconstruction of the town on another site, more stable from a geological point of view, called the “*Piano di Zona-Zone Plan*”, which had already been identified in a previous urban planning, following the 1930 earthquake [65–68]. In fact, there are currently two towns: Bisaccia Vecchia, an ancient village recovered around the ducal castle, and Bisaccia Nuova of the Area Plan, the latter almost completely rebuilt according to the urban plan drawn up by the architect Aldo Loris Rossi of the University of Naples [69], who was born in Bisaccia (Figure 34). A particular “*visionary*” architectural system [66–68] that brings us back to a utopian, futuristic city (Figure 35a,b), which has not received the unanimous consent of the population, but which is the clear, decisive testimony of post-disaster change (it could be compared to a modern Cerreto Sannita, destroyed by the earthquake of 1688 and rebuilt downstream with a regular architectural layout, still functional today due to its anti-seismic characteristics [70]).

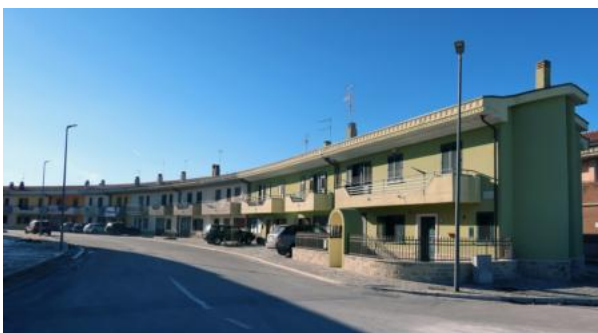
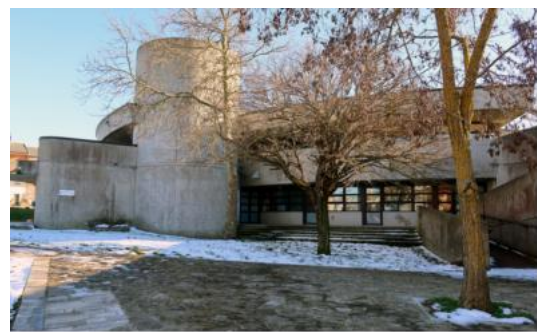
**Figure 35.** New Bisaccia town (Avellino Province): examples of new reinforced concrete buildings designed by architect Aldo Loris Rossi (Photo Porfido & Spiga, 2022). (a) Bisaccia reconstruction; (b) Detail reconstruction of Bisaccia.

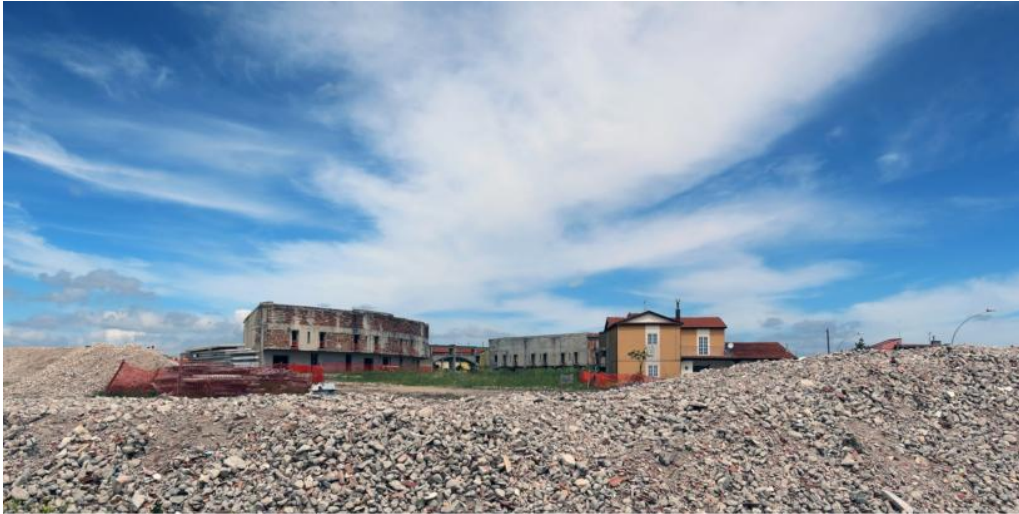
**Figure 37.** The social housing of Bisaccia.

In Bisaccia, the houses of the IACP (Autonomous Institute for Social Housing) also constitute an example of an inappropriate intervention with respect to the real needs of the population, which, contrary to the most optimistic forecasts of demographic increase (13,000 inhabitants were expected in the post-earthquake decade) suffered a notable contraction, in fact from the 4781 inhabitants registered in 1981, they became 3811 in 2017. Originally, 83 IACP appartements were planned, subsequently reduced to 75, again based on the architectural layout of A. Loris Rossi. After various events linked to construction companies, a redevelopment and completion process has finally started for 18 homes, the rest of the homes have been demolished (Figure 37), not without a waste of public resources [40,42,43,72].
